Strain Measurement Using FBG on COPV in Stress Rupture Test

Curtis Banks EV43 & Joseph Grant VP63

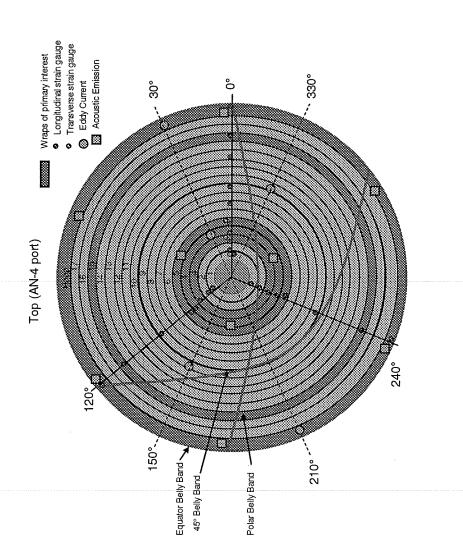
Figure 3. Top view of AN-4 Port

The OMS vessel was instrumented with 36 FBG sensors (figures 3 and 4). Three sensors were placed transverse on the zero axes and three in transverse on the 180 axis. The remainder of the thirty was installed in the longitudinal direction (20 on top and 10 on bottom). Keeping with the last centaur test, FBGs sensors were taped down with several layers of kapton tape for each sensor to reduce peak splitting. Then they were attached to the surface of the vessel using M- Bond GA-2. The surface of the vessel was sanded using a 600 grit sand paper and cleaned with isopropyl alcohol. This was done to insure good adhesion of the optical fiber to the vessel surface. Once all of the sensors were bonded, they were tapped down to prevent any loose fiber from entanglement with other wires on the vessel that might cause the FBG to break. We mounted L- shaped connector holders to the vessel surface using double sided tape. This made it easier to connect two 10ft patch cables from the vessel to the FBG interrogation system. The order of each labeled sensor line is noted it the Table 1. The table starts with the sensor number followed by the sensor string. The location, orientation and wrap are listed for each sensor. Lastly, the location for each sensor string as it is connected to the vessel is listed in the columns showing top or bottom for the connections.

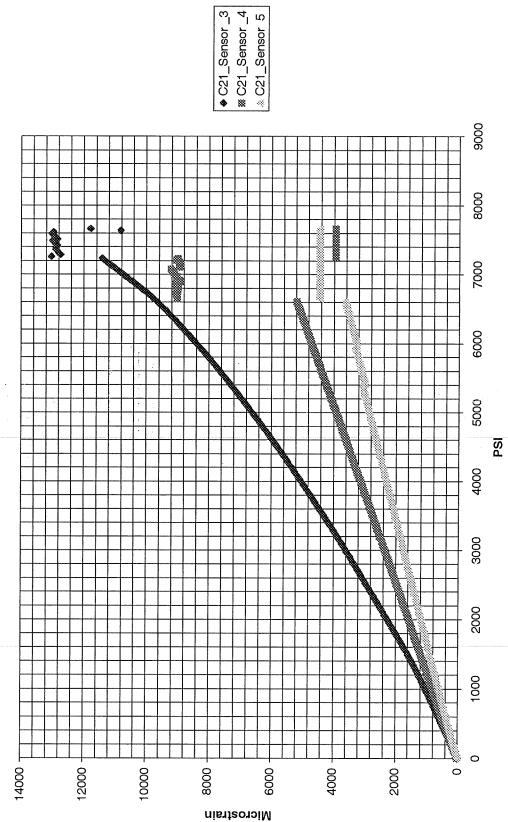
In Figure 5 we see as example of three different loading levels along the 120 degree line of the top hemisphere, (sensors 3, 4 and 5). The direction of the gauges is along the COPV wrap. The loading is linear with pressure. However, the maximum strain experienced by the sensors are, 13025.5, 8985.0, and 3536.7 (micro strain) while the pressure per square inch experienced was 7586, 76725, and 6613, respectfully. These values are at or near the point where the COPV ruptured, 7667 psi.

One may also note that a brakeage in the plots can be seen. These brakeage can be attributed to several effects; one, it maybe from the onset of the liner beginning to yield to the stress, becoming plastic. Second, underline cracks may have reached some critical load level. Or, underline Kevlar strain(s) giving way and the loading is being transferred to adjacent strains as pressure inside the vessel continued to increase until failure.

The breakage in the data seems to be an onset of a plateau region. The plateau may indicate that the Kevlar has reached its yielding level or the fiber optic cable may have reached its yielding limit.

Figure 5. FBG sensors 3, 4 and 5 showing onset of liner yield. Sensors are located in the top hemisphere on wraps 4L, HL, and 15L along the 120 degree line.

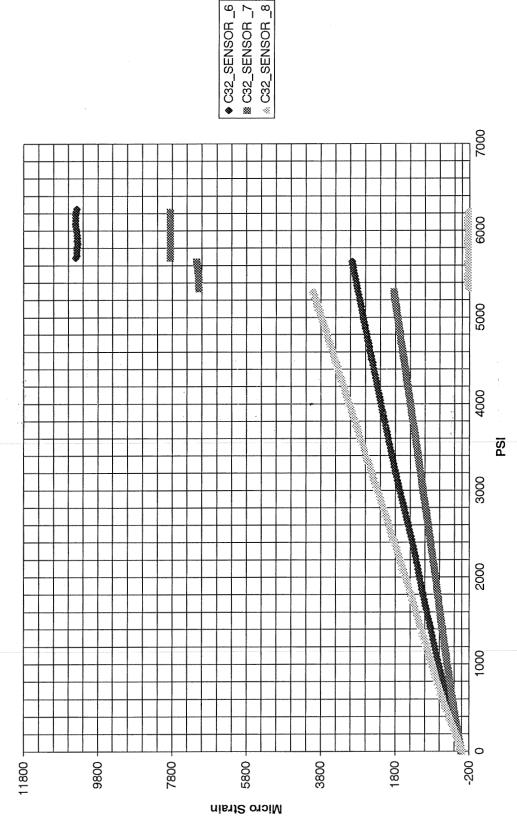
Similar results can be seen in Figure 6 (sensors 6, 7, and 8). The strain is measured along the 180 degree line on the bottom hemisphere. The maximum strain is compatible to the level measured by sensors 3, 4, and 5. However, sensor 8 failed as the pressure levels read 5300 psi. Here the adhesive may have given way. The COPV was coated with a layer of polyurethane that had been exposed to ultra violet rays for several years. Moreover, flaking of the Polyurethane was noted while applying the FBGs to the COPV. If the epoxy adhesive gave way under stress this would account for the zero loading at this pressure.

psi. The failure may be due to adhesive related problems or underline polyurethane. Sensors Figure 6. FBG sensors 6, 7 and 8 showing onset of liner yield. Sensor 8 failed above 5250 are located in the bottom hemisphere on wraps 5T, 3T, and 1T along the 180 degree line.

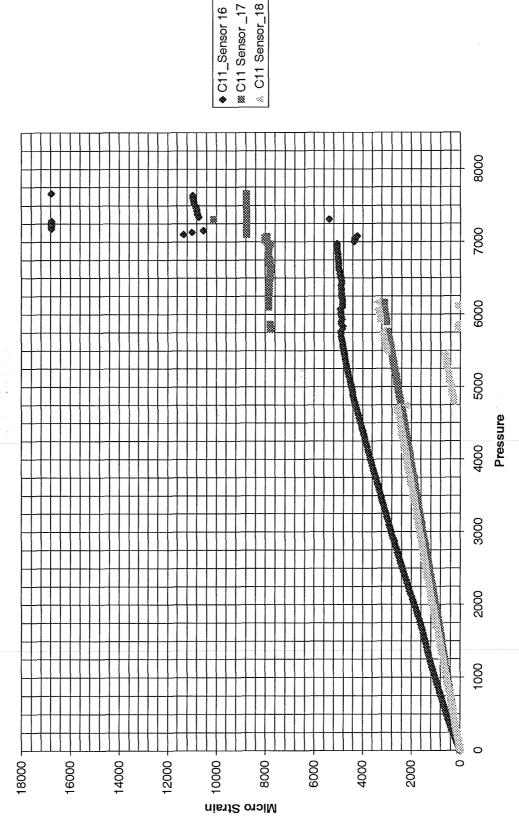
FBG Sensors 16, 17, 18

Figure 7 represents sensors 16, 17 and 18. These sensors were mounted transverse to the direction of the wrap along the 0 degree line and located on the top hemisphere. The sensors are on wraps 5T, 3T, and 1T. The strain levels in these sensors are generally lower because the loading along the direction of wrap were more than the loading transverse to the wrap.

Figure 7. Sensors 16, 17 and 18 were attached transverse to the wrap direction. Ideally, the stress generated in the Kevlar wrap is smaller than along the wrap. Sensors are located in the top hemisphere on wraps 5T, 3T, and 1T along the 0 degree line.

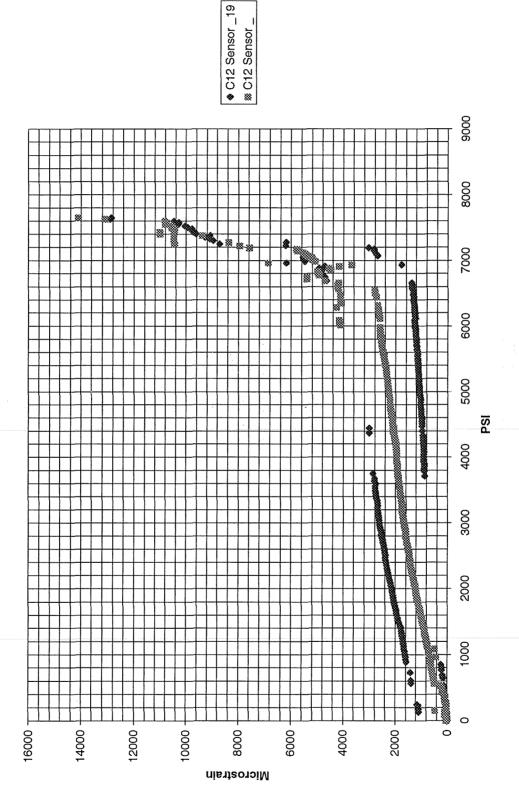
Spliting of Peeks Sensor 19

In Figure 8 we illustrate peek splitting using a long FBG (sensor 19). It is located along the 0 degree line A FBG sensor is prone to splitting if it is placed on a curved surface (4). The BRR FBG interrogator cannot properly track the major peak shift when it is under stress. It sees two peaks from the one sensor. The major peek is at 1530 nm and the minor peek is located 1533 nm. Quantitatively, each sensor follows the increase strain with increase pressure. Hence, it is important to properly balance sensitivity (long Braggs Grating) with peak design requirements.

surfaces. The splitting makes difficult to interpret the underlying strain. Sensor is located in the Figure 8. Sensor 19 shows that splitting can occur if the FBG if the sensor is placed on curved top hemisphere on wraps 5L alone the 0 degree line.

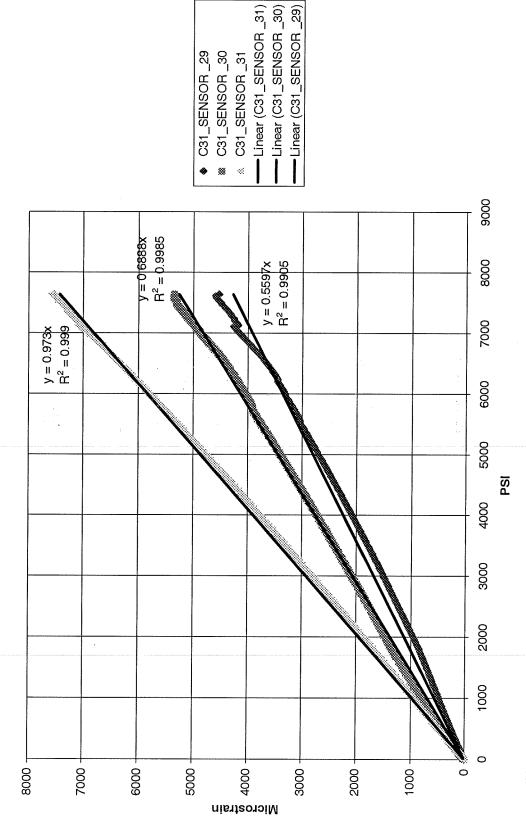
Finally, Figure 9 shows sensors 29, 30, and 31. Sensors 30 and 31 are located on the 300 degree line in the bottom hemisphere and wraps 15L and 2L, respectfully. Each sensor is well behaved and is linear with increased pressure. The maximum strain experience by sensors 31 is greater than that of sensor 30.

Sensor 29 on the contrary, is located along the 180 degree line in the bottom hemisphere on wrap 4L. It is also well behaved and linear with applied pressure.

The liner yield seems to be absent from these sensors. This may suggest that the yield maybe location sensitive.

sensors. Sensors are located in the bottom hemisphere on wraps 4L 180 degree for sensor 29 and Figure 9. Sensors 29, 30 and 31 were behaved. The liner yield seems to be absent from these wraps 2L and 5L alone the 300 degree line for 30 and 31.
